BUTLER PIKE TODAY

This study focuses on a nine mile long segment of Butler Pike from the intersection with North Lane in Plymouth Township to the intersection with Limekiln Pike (PA 152) in Horsham Township. It does not include the segment within Ambler Borough, which is locally known as Butler Avenue. Butler Pike functions as a principal arterial, and it supports regional mobility between Plymouth Township, Whitmarsh Township, Whitpain Township, Ambler Borough, Upper Dublin Township, and Horsham Township. Butler Pike provides these communities with access to the PA Turnpike in Plymouth Meeting and the Fort Washington Expressway (PA 309) in Upper Dublin Township.

BUTLER PIKE TOMORROW

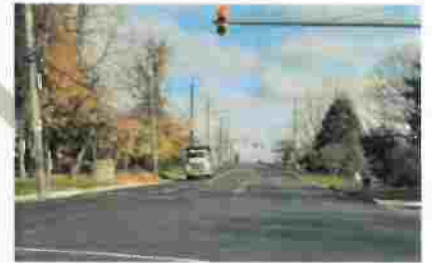
Butler Pike consists of one travel lane in each direction for the entire length of the study area. Between North Lane and Ridge Pike, Butler Pike has a three-lane cross section with a center turn lane. Shoulder widths vary along Butler Pike. The graphics below depict the typical cross-sections that may be found along the corridor.

Example of Three Lane Cross-Section on Butler Pike

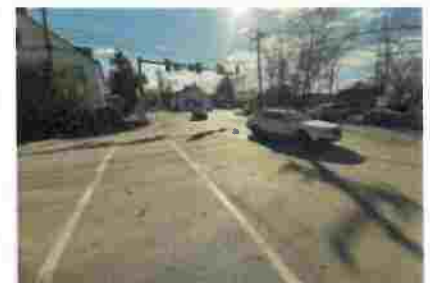
The intersection of Germantown Pike and Butler Pike is one of the most critical and challenging. Butler Pike is offset by approximately 100 feet. This, along with high traffic

Intersection of Butler Pike and Germantown Pike

volumes on both roads, has resulted in the highest concentration of crashes along Butler Pike. Additionally, this intersection is the crossroads of the Plymouth Meeting Village and is within a National Historic Register District. Community members expressed an interest in improved pedestrian connections at this intersection.

A high concentration of vehicle crashes are documented along Butler Pike at the intersection of Butler Pike with Germantown Pike, which saw a total of seventeen crashes between 2015-2019. This intersection has unusual intersection geometry, which likely contributed to crashes. Many of these crashes can be attributed to poor weather (wet and/or icy conditions) and driver error (too fast for conditions, improper turn, proceeding without clearance). Concentrations of crashes have also been reported at the intersection of Butler Pike with Plymouth Road/Flourtown Road, Narcissa Road, Susquehanna Road, and Norristown Road, however crashes at these intersections occur at a lesser frequency than at Germantown Pike.

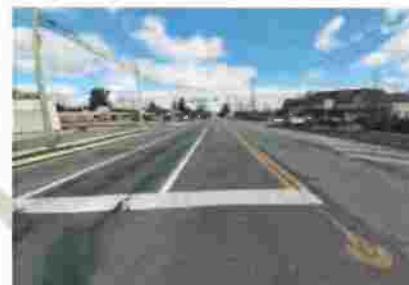
There are several shopping centers along Butler Pike with multiple commercial driveways or wide open driveways without proper access and traffic controls. In some areas, it is difficult to distinguish the edge of the roadway with the start of a parking lot. This impacts safety and operations for vehicular travel, as well as safety for bicyclists and pedestrians crossing the access ways.

Close Spaced Commercial Driveways Near the Intersection of Butler Pike and Skippack Pike

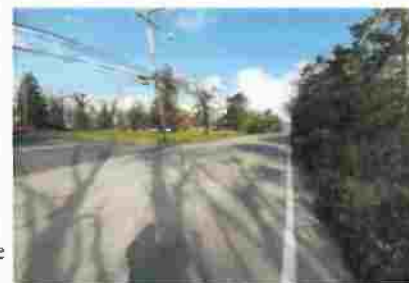
The urban/suburban nature of Butler Pike means that, in many areas, there is limited space to accommodate additional transportation facilities. Along many segments of the corridor, constraints outside of the county's publicly owned right-of-way, such as structures, utility poles, residential fences/decorative walls and heavily wooded and vegetated areas close to the roadway, impact the feasibility of implementing some improvements such as wider shoulders, additional travel lanes, vehicle turning lanes, on-road bicycle facilities, pedestrian facilities, or stormwater management facilities.

Narrow Shoulder Along Butler Pike

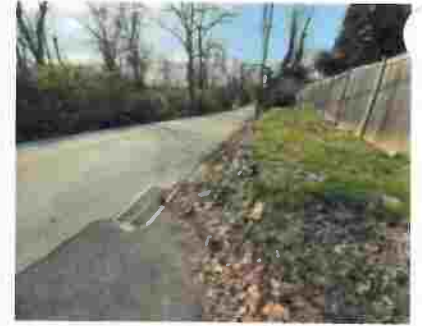
It is very common along many areas of Butler Pike for several types of obstructions to be located close to the paved cartway including areas of trees/heavy vegetation, fences, decorative walls, utility poles, and building structures.

Roadside obstructions near Township Line Road, Whipton Township

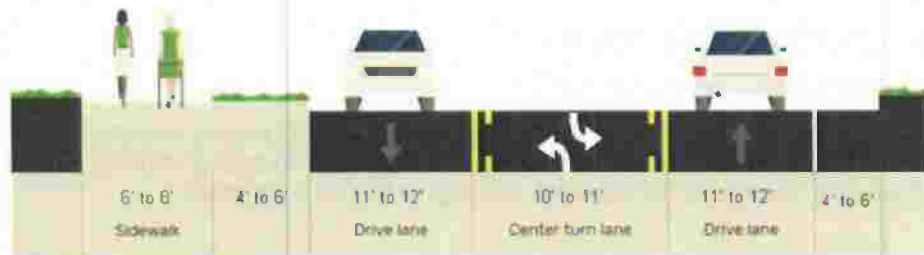
Butler Pike to Locust Street

The existing cross section of Butler Pike from Conshohocken Borough to the north of Flourtown Road/Plymouth Road near Campus Drive will generally remain the same as existing with improvements to provide a consistent cross section. Pedestrian and bicycle accessibility will be improved by filling in gaps and providing a consistent width for the extensive sidewalk network that exists, providing buffer areas, improving bus stops, and providing consistent shoulder widths.

Gaps in the existing two-way center left turn lane may be filled where feasible to improve traffic operations and safety along the corridor. A two-way center left-turn lane exists from North Lane to Karris Lane approximately 700 feet north of Ridge Pike. The lane should be extended further north to a location south of Germantown Pike such as Shasta Lane/Cardinal Drive or Blue Ridge Road.

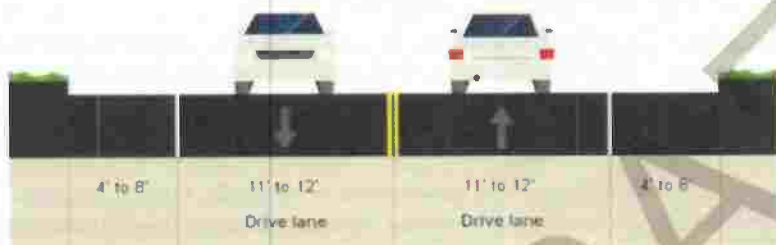
Campus Drive to Locust Street

The cross section which generally traverses the segment of Butler Pike beginning just south of the PA Turnpike overpass to the boundary of Ambler Borough will largely remain the same with improvements to the roadway to provide consistent preferred shoulder widths on both sides of Butler Pike. Sidewalks should be provided in key areas to connect closely spaced pedestrian generators. Pedestrian connections should be developed between the village of Broad Axe and the Wissahickon trail crossing.

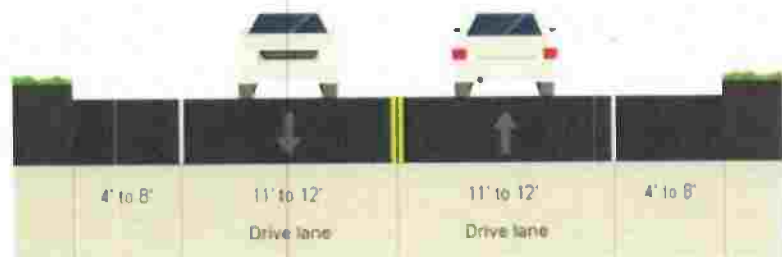
The cross section which generally traverses the segment of Butler Pike beginning at the northern boundary of Ambler Borough at Bethlehem Pike to the northern end of the corridor in Horsham Township will largely remain the same. The existing trail and sidewalk segments located on the west side of Butler Pike should be utilized to provide a shared pedestrian and bicycle facility for the entire segment. The location of the trail shown in the cross section of Bethlehem Pike to Limekiln Pike—PA 152 may need to alternate between the west and east sides of the road, with well established crossings at signalized intersections or mid-block locations, to reduce impacts to constraints and available right-of-way and easements. Since the shoulders will not be needed for bicycle use and due to the amount of roadside obstructions and constraints along this segment, a narrow shoulder can be provided at a consistent width.

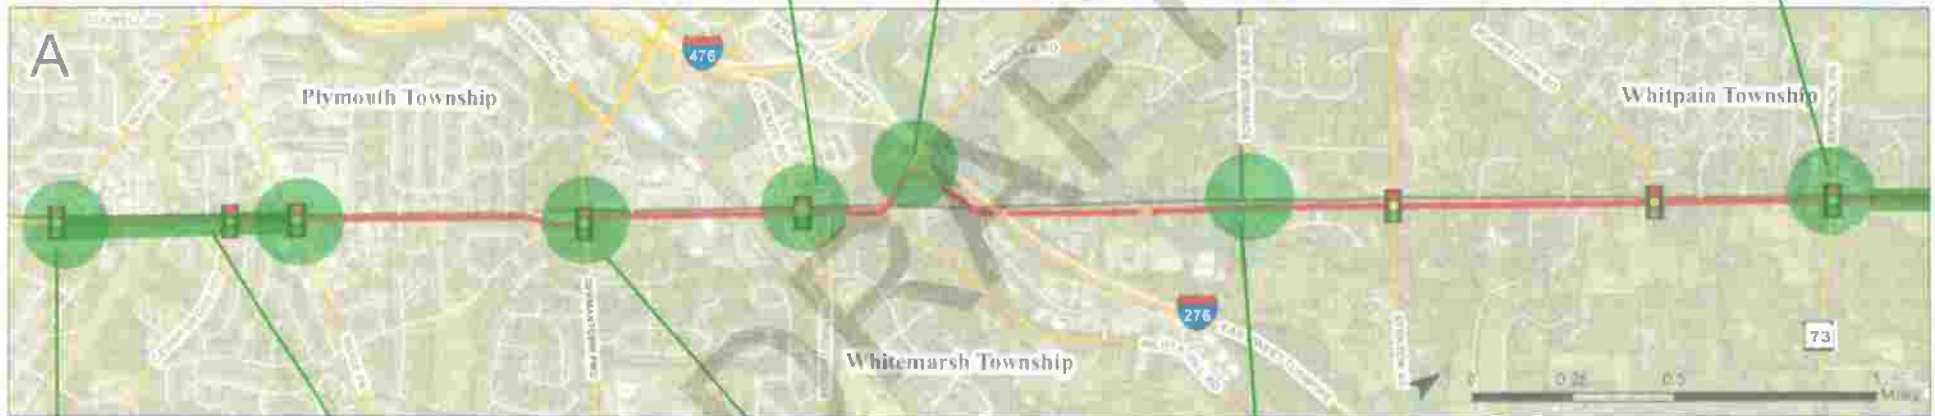
Butler Pike | Corridor Improvements

Intersection with Plymouth Road/Flourtown Road

Priority: Medium
Cost: SSSS

- Add turning lanes
- Traffic signal upgrades

Intersection with North Lane

Priority: Low
Cost: SS

- Add turning lanes

North Lane to Ridge Pike including Ridge Pike Intersection

Priority: High
Cost: SSSS

- Traffic signal upgrades
- Upgrade pedestrian facilities
- Bus stop amenities

Intersection with Germantown Pike

Priority: Medium
Cost: SSS

- Modify existing turning lanes
- Traffic signal upgrades
- Upgrade pedestrian crossings and signals
- Bus stop amenities

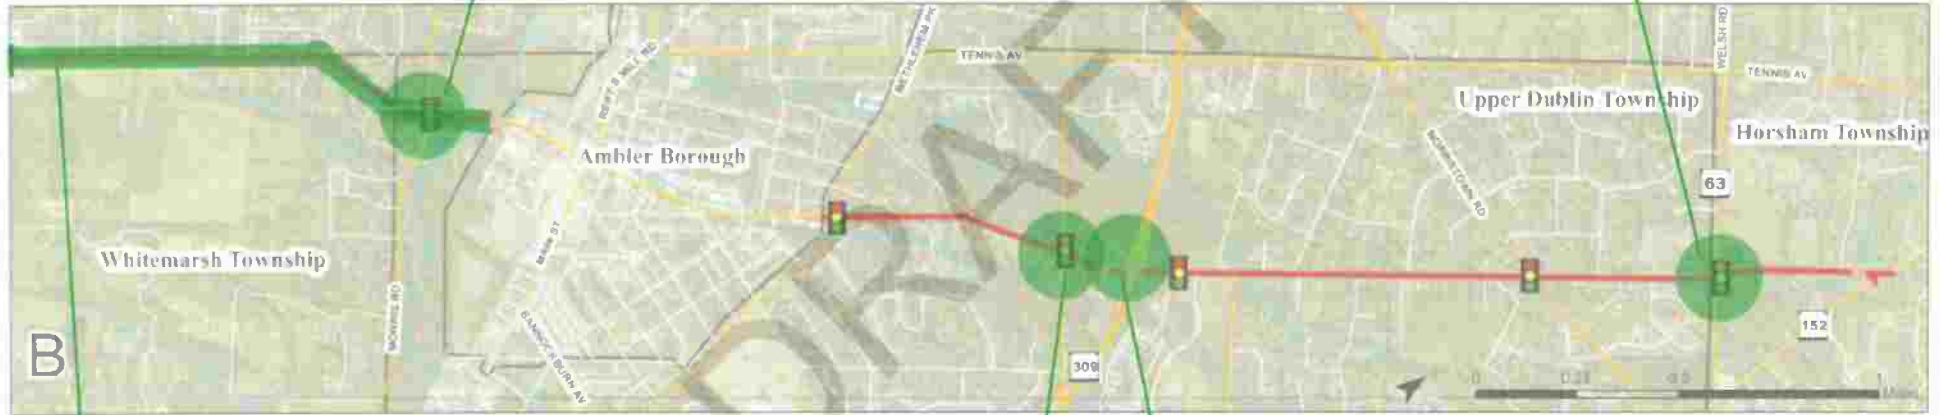
Butler Pike | Corridor Improvements

Intersection with Morris Road

- Priority: Medium**
Cost: \$\$
- Add turning lanes
- Traffic signal upgrades

Intersection with Welsh Road

- Priority: High**
Cost: \$\$\$
- Add turning lanes
- Realignment
- Upgrade pedestrian crossings and signals

Skipack Pike to Ambler Borough

- Priority: High**
Cost: \$\$\$\$
- Need for improved pedestrian or multi-use trail connection
- Need to connect and provide a safe crossing for the Wissahickon Green Ribbon Trail

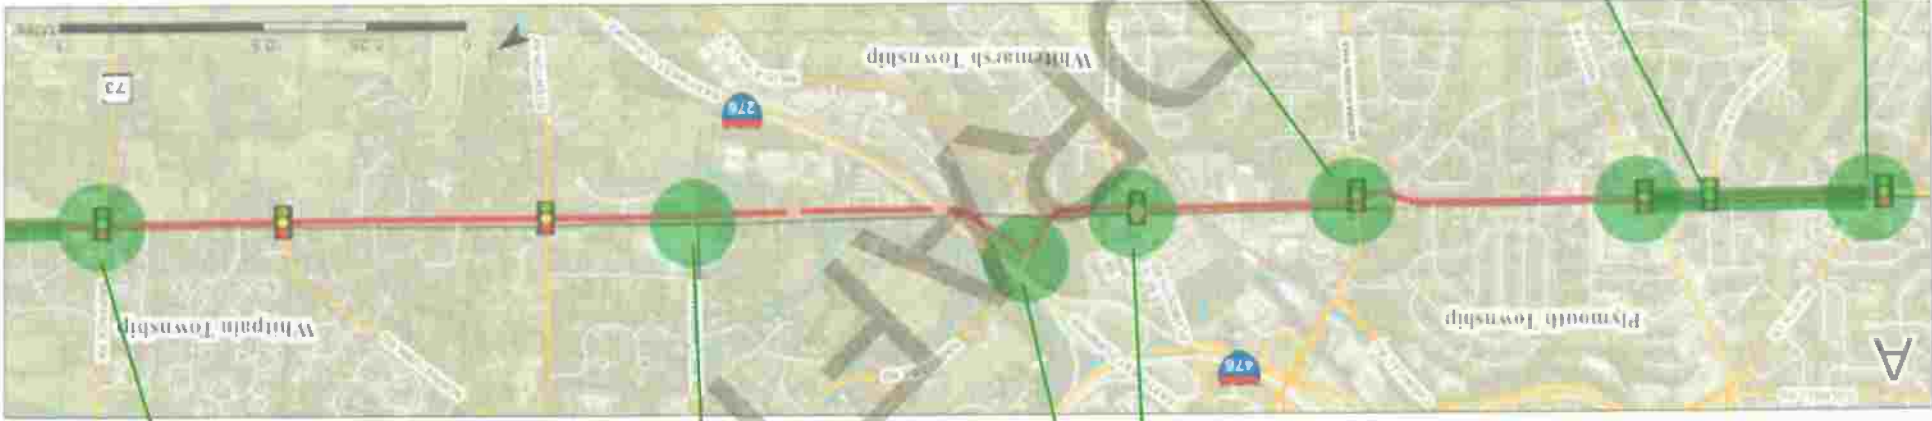
Butler Pike | Key Issues

Intersection with Narcissa Road

- Intersection geometry (sharp curve, topography, and off/stop controlled intersection) cause safety deficiencies

Intersection with Plymouth Road/Flourtown Road

- Capacity deficiencies

Intersection with Germantown Pike

- Unusual intersection geometry (offset) causes safety and operational deficiencies
- High concentration of crashes
- Congestion and capacity issues on Germantown Pike at the intersection
- Need for new/upgraded sidewalks and pedestrian crossings at the intersection
- Desire to provide a connection between Butler Pike and the Cross County Trail (at the intersection of Germantown Pike and Chemical Road)
- Crossroads within the Plymouth Meeting Village National Historic Register District with several historic resources nearby
